# LAKE BEAUTY

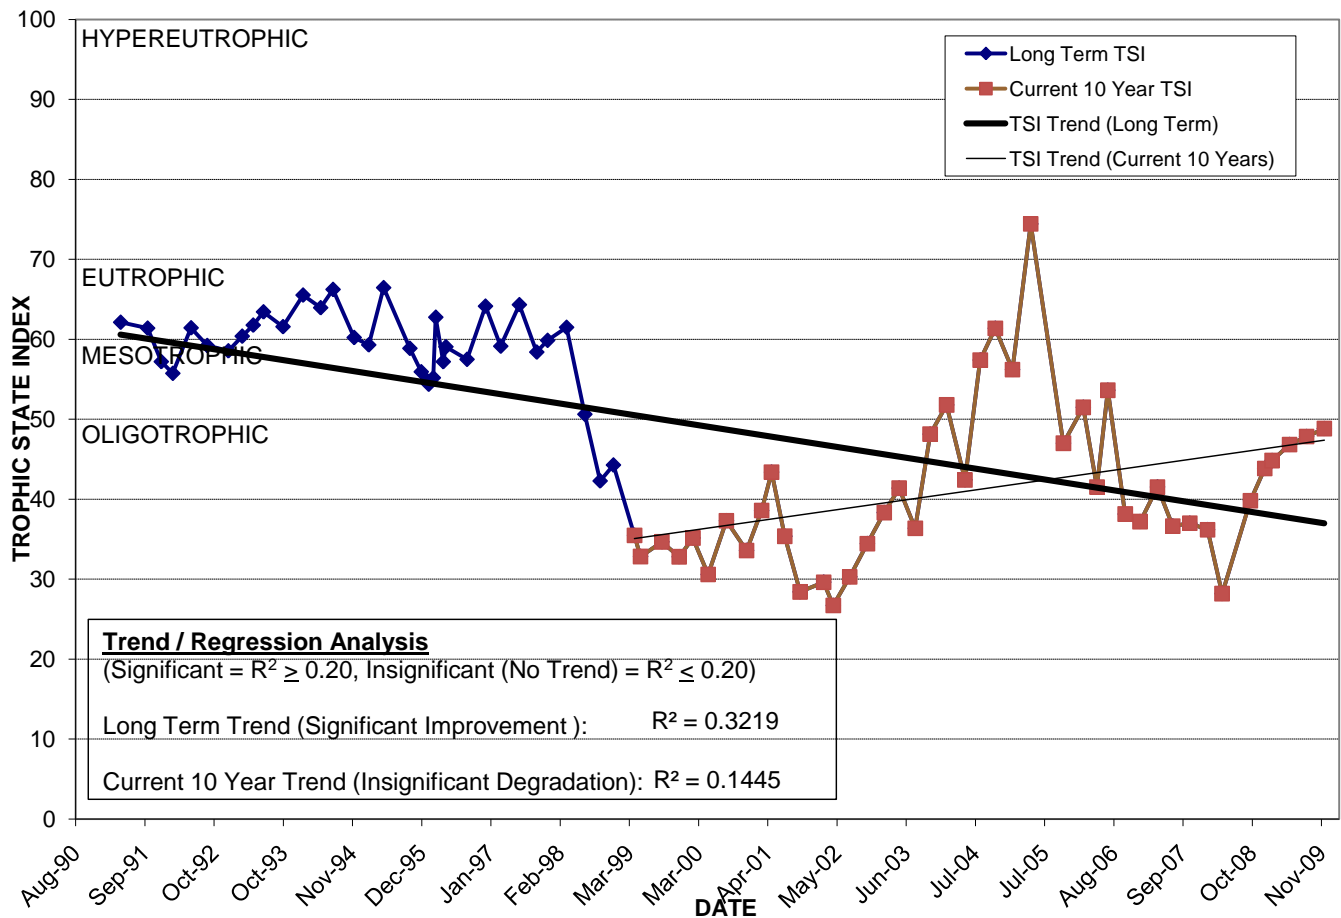
**Long-Term Trophic State Index Values and Linear Regression Trend Line**

2009 Water Quality Data		TSI Ranking: 39 (out of 95 lakes)			
	Total Phosphorus (mg/l)	Total Nitrogen (mg/l)	Secchi Depth (m)	Chlorophyll-a (mg/m <sup>3</sup> )	Trophic State Index
Minimum	0.023	0.41	0.7	2.1	45
Maximum	0.031	0.51	2.8	7.5	49
Average	0.028	0.44	2.1	4.6	47
